STATE OF ILLINOIS
DEPARTMENT OF TRANSPORTATION

BEAM STRAIGHTENING DETAILS
SN 090-0091
SHEET NO. 2 OF 6 SHEETS

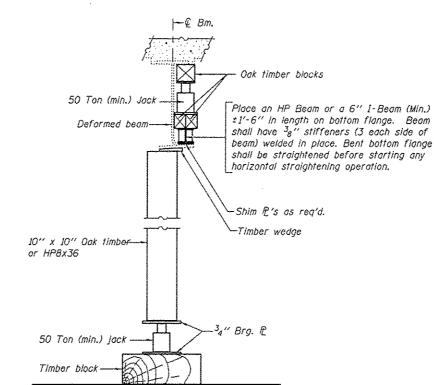
# SUGGESTED VERTICAL STRAIGHTENING DETAIL

(To correct flange rotation.)

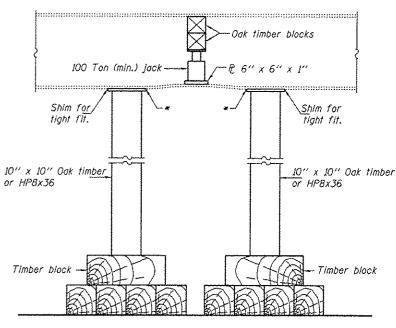
## SUGGESTED VERTICAL STRAIGHTENING DETAIL

(To correct localized vertical flange deformations.)

\* Edge of plate shall line up with edge of deformation.

Braces and jack assembly shall be placed on same side of web. Bent bottom flange shall be straightened before starting any horizontal straightening operations.
